U.S. Department  
of Transportation

National Highway  
Traffic Safety  
Administration

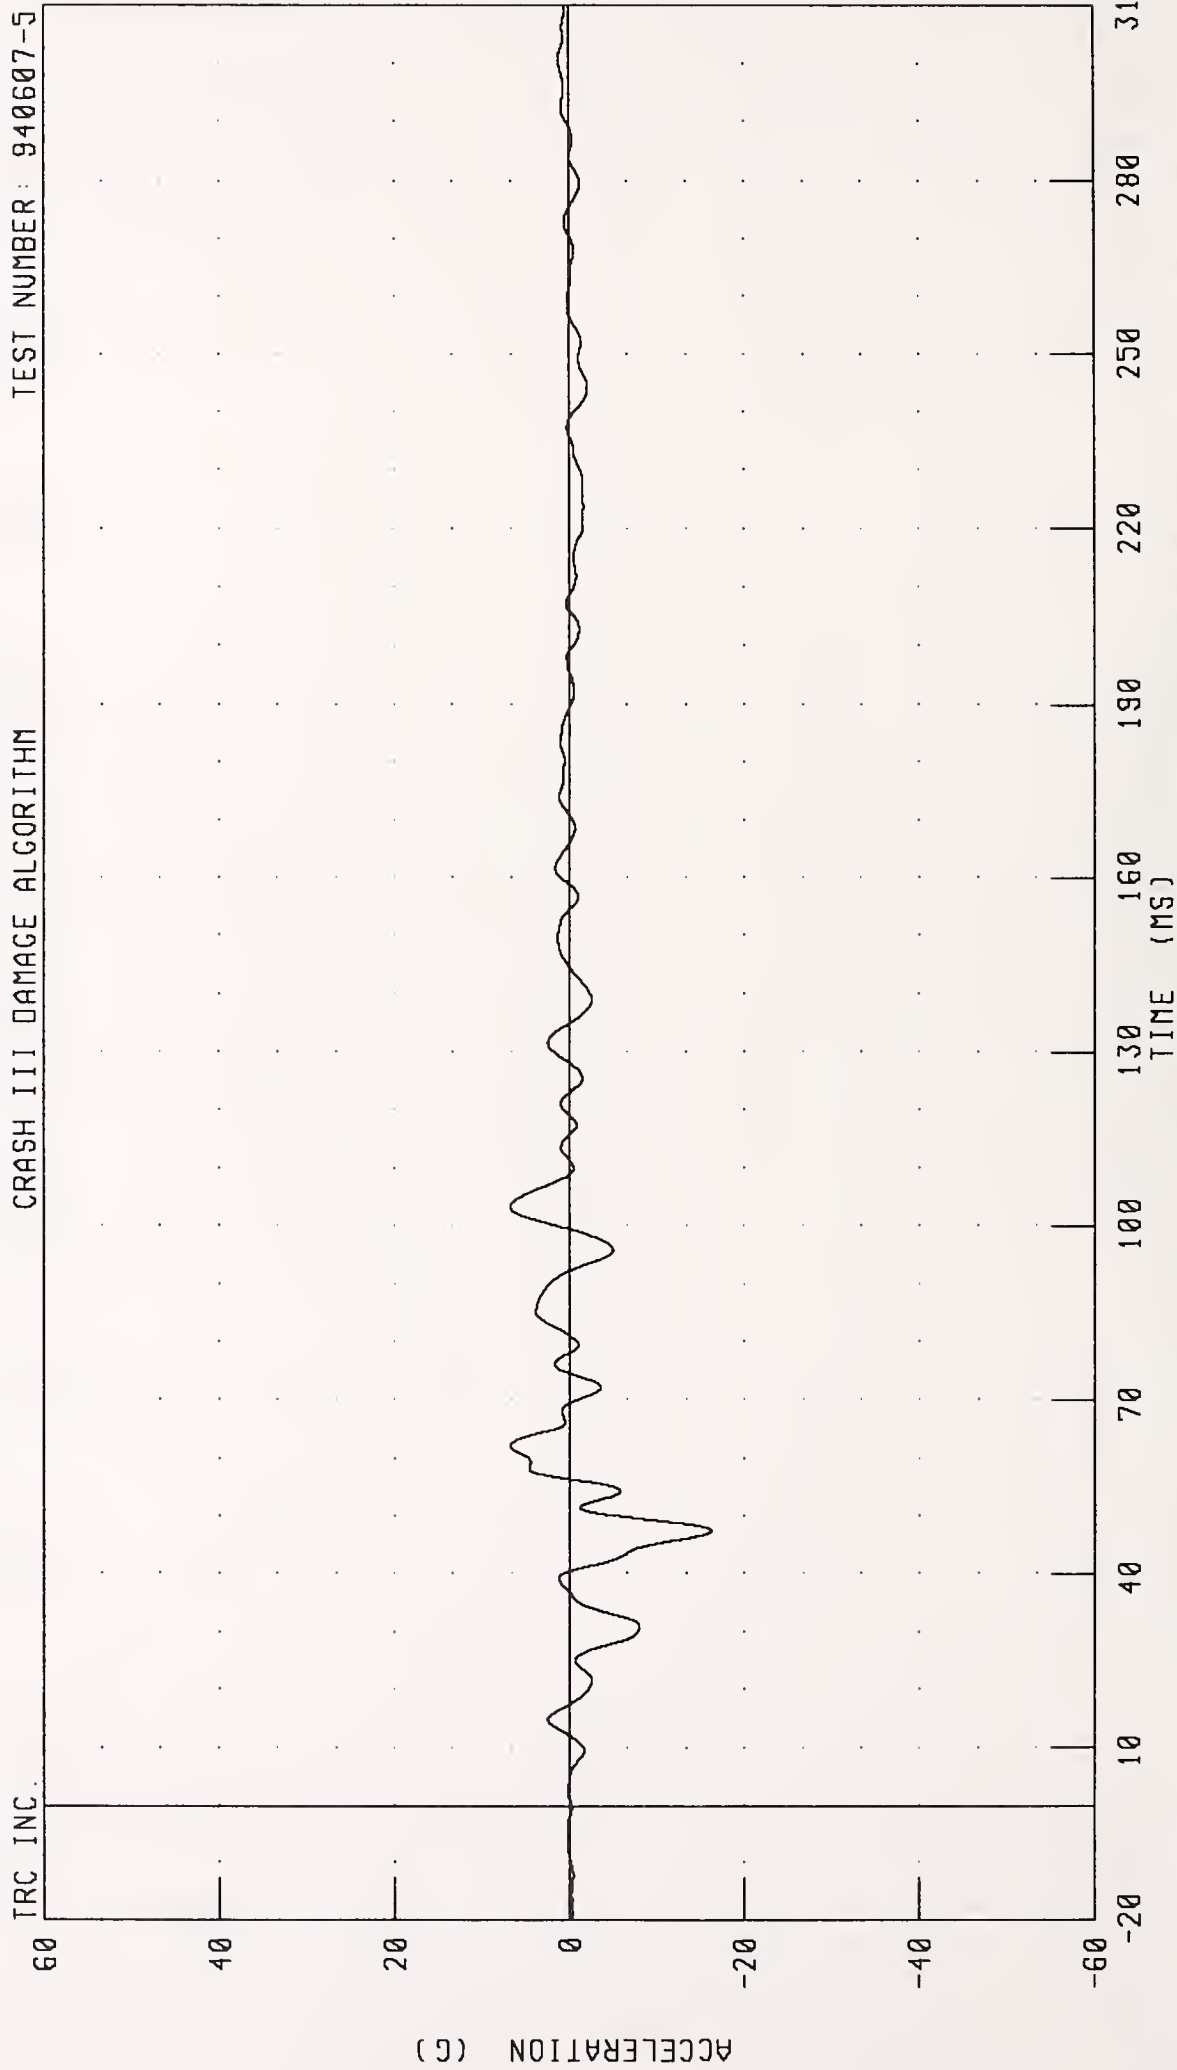
CHANNEL: RRSYG1 FILTER: CH. CLASS 60

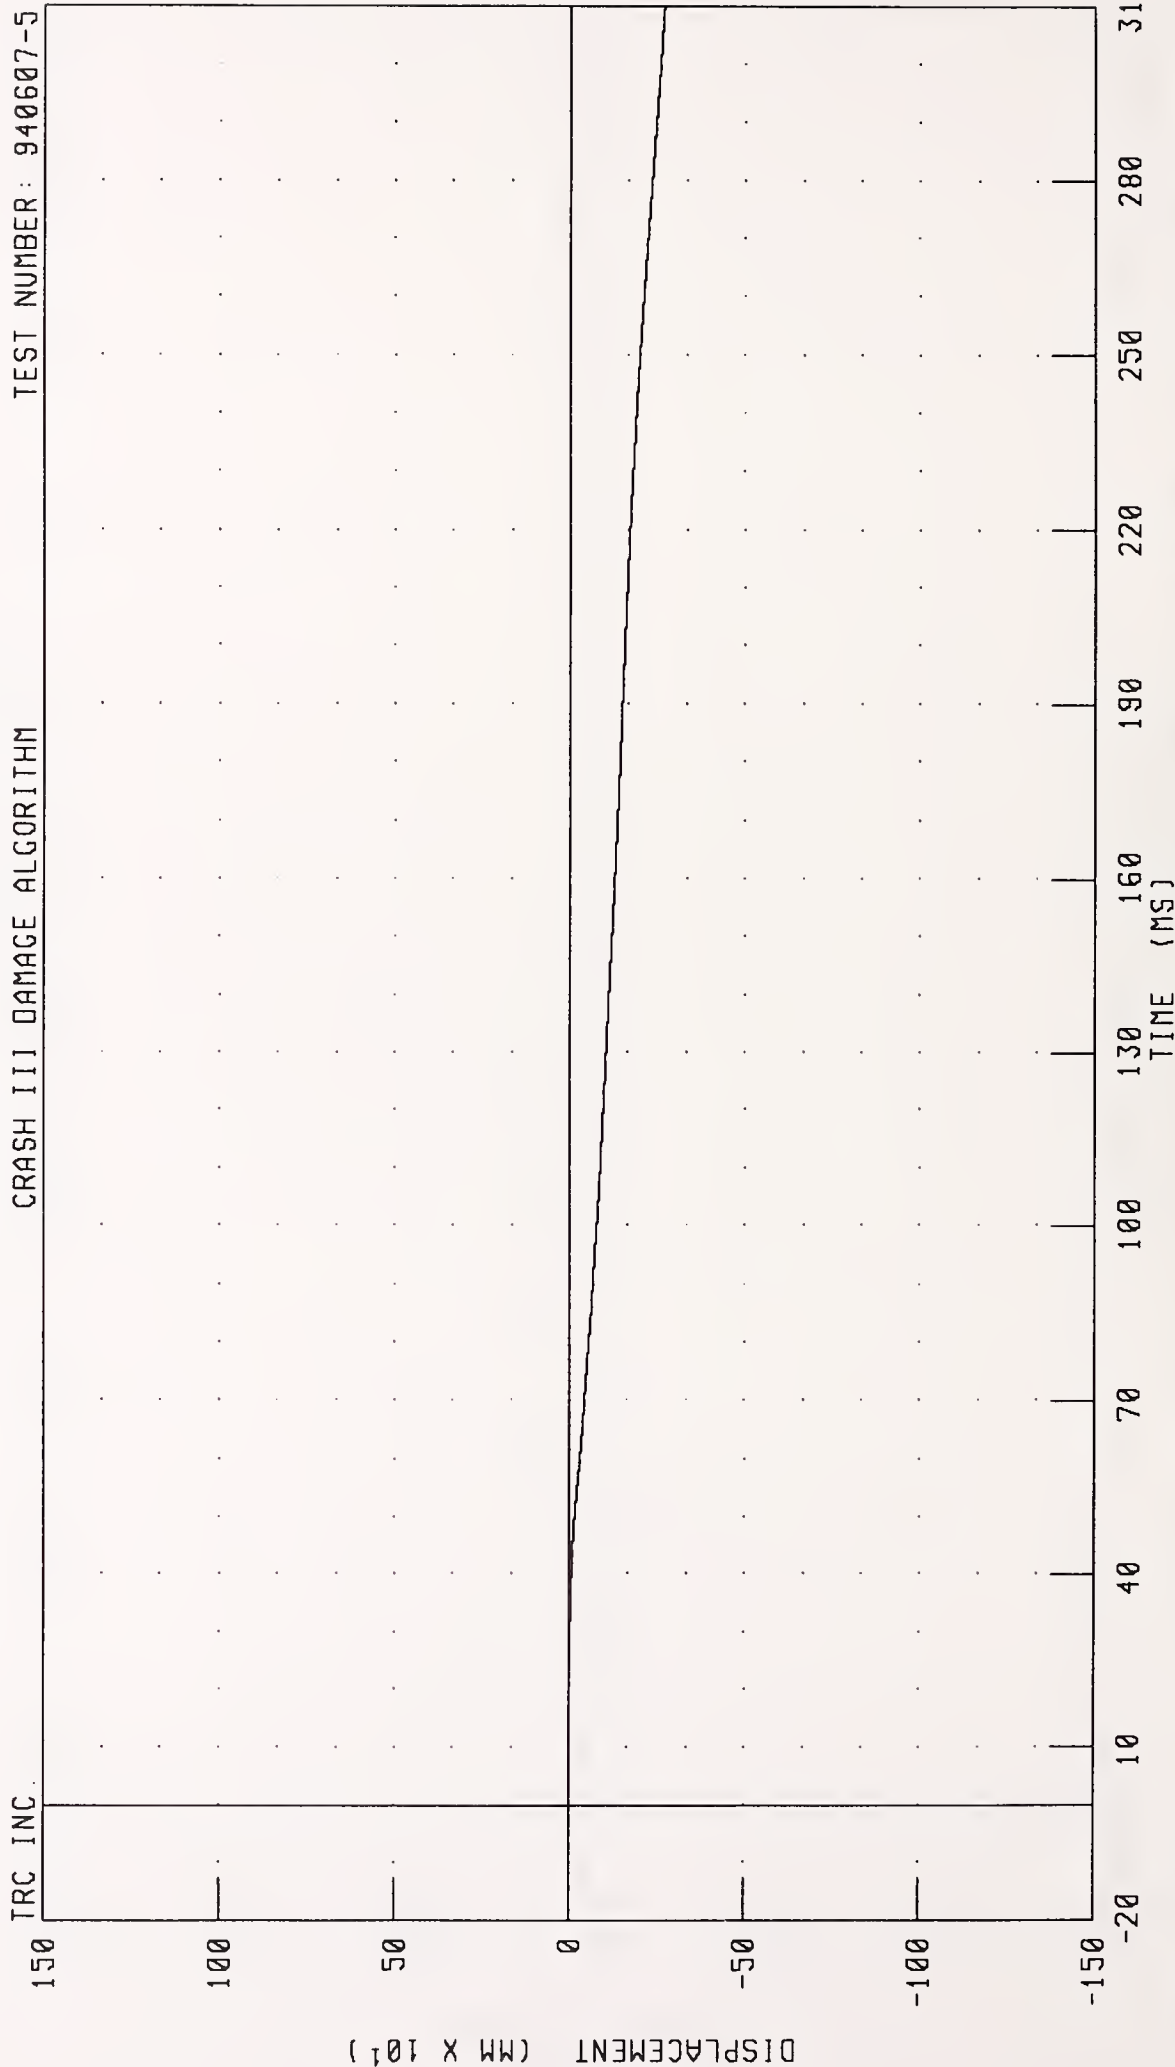
CHANNEL: RRSYD1 FILTER: CH. CLASS 180
